# National Transportation Safety Board Aviation Accident Final Report

<b>Location:</b>	Elizabethton, TN	<b>Accident Number:</b>	ERA19FA248
<b>Date &amp; Time:</b>	08/15/2019, 1537 EDT	<b>Registration:</b>	N8JR
<b>Aircraft:</b>	Textron Aviation Inc 680A	<b>Aircraft Damage:</b>	Destroyed
<b>Defining Event:</b>	Runway excursion	<b>Injuries:</b>	3 Minor, 2 None
<b>Flight Conducted Under:</b>	Part 91: General Aviation - Business

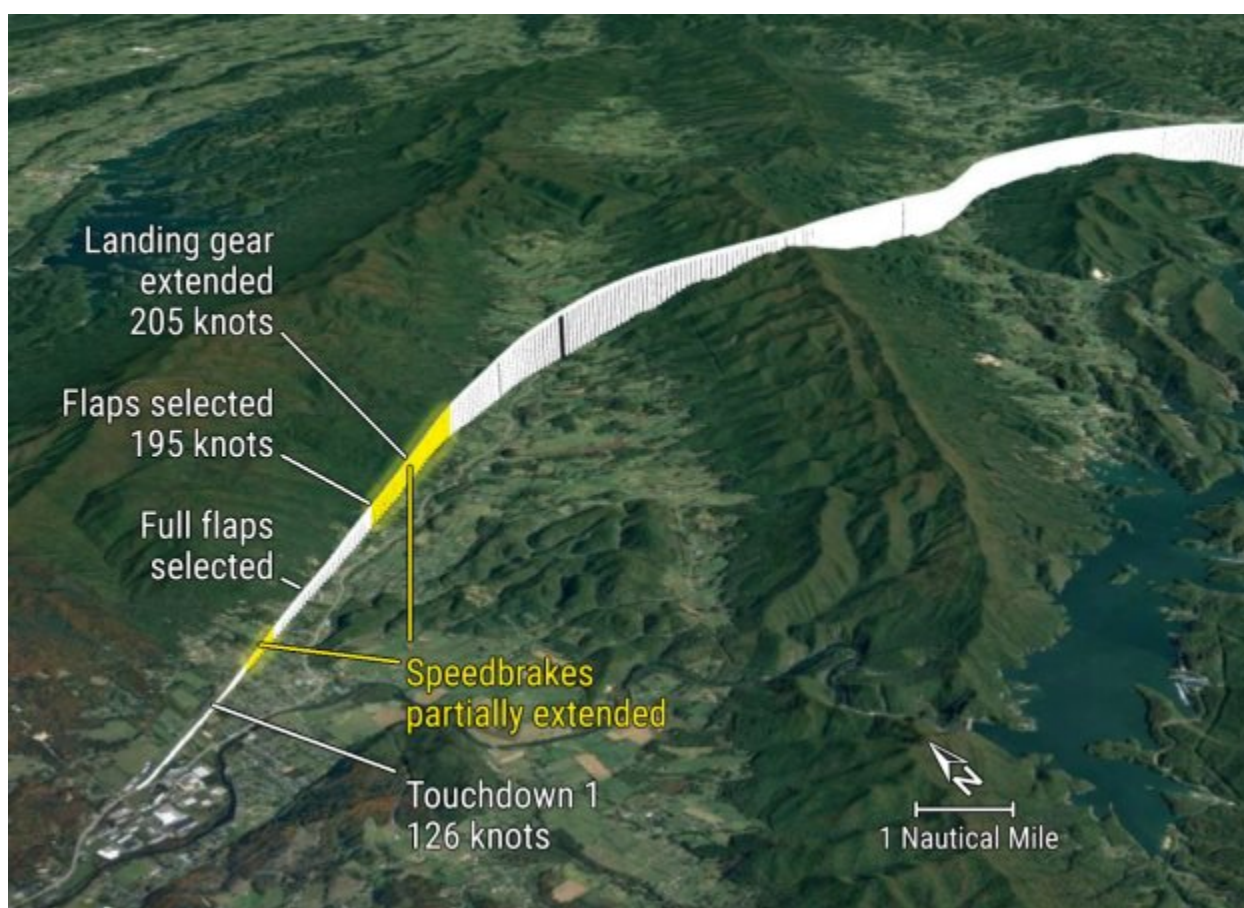
The airplane's approach was unstabilized: its airspeed during the approach and landing well exceeded  $V_{ref}$  and its descent rate exceeded the maximum allowed for landing just seconds before touchdown. Both the pilot and copilot commented on the airplane's high speed several times during the approach. During short final, the pilot asked the copilot if he should go around, and the copilot responded, "no." Although the copilot was the director of operations for the flight department and the direct supervisor of the pilot, the pilot stated that the copilot's position did not influence his decisions as pilot-in-command nor did it diminish his command authority. Neither the pilot nor copilot called for a go-around before landing despite awareness that the approach was unstabilized.

Figure 1: N8JR's approach, including speed and use of speedbrakes (in yellow), landing gear, and flaps.

As the flaps were extending, the TAWS forward looking terrain alert rate of terrain closure caution alert sounded twice (at 1536:59 and at 1537:09), then a warning alert sounded (at 1537:11). The airplane was at an altitude of 2,159 ft msl (471 ft agl). Following these alerts, the copilot selected full flaps and the descent rate and airspeed decreased. At 1537:26, the copilot

stated, "and I don't need to tell ya, we're really fast," and the pilot responded, "I'm at idle." Six seconds later, the pilot asked, "do I need to go around?" and the copilot responded, "no." At 1537:31, about 270 ft agl, the speedbrakes were partially extended for 5 seconds (to 140 ft agl). The pilot then stated, "I got the speed brakes out," to which the copilot responded, "well you should get rid of those because we don't wanna get a CAS [Crew Alerting System] m- or a thing sent to ya." Eight seconds before touchdown, at 1537:41, the pilot stated, "alright, I'll be on the T-Rs [thrust reversers] quickly." For the computed airplane weight, the reference speed ( $V_{ref}$ ) for the final approach was 108 knots; the airplane's airspeed at the runway's displaced threshold was 126 knots. Five seconds before touchdown, the airplane's descent rate was over 1,500 ft per minute (fpm).

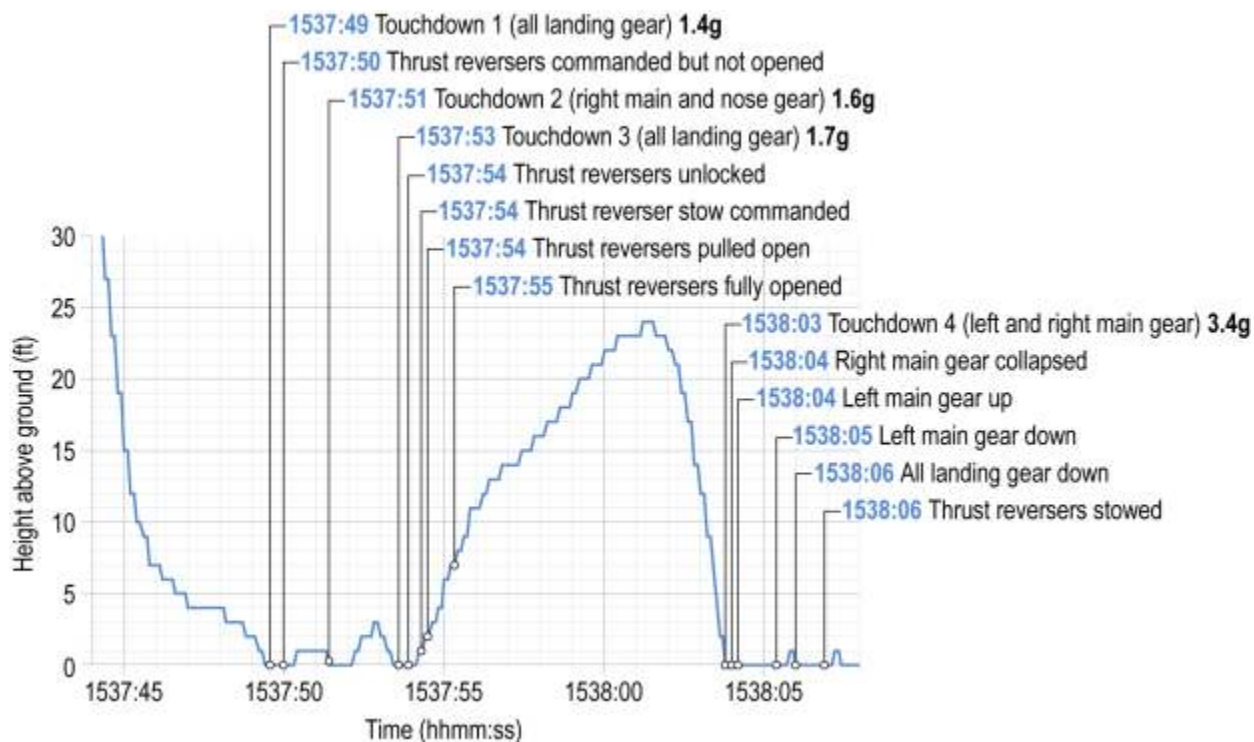
Figure 2. Graph depicting the airplane's thrust reverser actions, landing gear touchdowns, and vertical acceleration (**bold**) during its bounced landing.

When the airplane touched down initially at 1537:49, it was travelling 126 knots (18 knots above  $V_{ref}$ ) and had a descent rate of 600 fpm (the maximum allowed per the airplane flight manual [AFM]). All three landing gear registered "on-ground" simultaneously with a vertical acceleration of 1.4 gravitational acceleration (g), and thrust reverser deployment was commanded 0.4 second after the landing gear first touched the ground as the throttles were moved to the reverse idle position; however, the airplane bounced after touching down for 0.6 second and was airborne again before the thrust reverser command could be executed.

When the airplane touched down a second time, 1.2 seconds later at 1.6 g, the nose landing gear touched down first, followed immediately by the right main landing gear. The left main landing gear never registered on-ground during the touchdown, and the airplane bounced and became airborne again after 0.4 second.

The airplane touched down a third time, 1.8 seconds later at 1.7 g and about 1,000 ft down the runway with about 3,100 ft of paved surface remaining. The thrust reversers unlocked 0.4 second after all three landing gear registered on-ground because the reverser deployment command from the first touchdown was still active. Almost immediately after the thrust reversers unlocked, the pilot advanced the throttles to idle, sending a thrust reverser stow command at 1537:54; however, the landing gear status changed to "in-air" almost simultaneously when the command was executed.

The airplane bounced after 0.6 second and became airborne a third time, and the in-air landing gear status triggered a cut in hydraulic power to the thrust reverser actuators, which is intended to prevent the airborne deployment of a thrust reverser. The cut in hydraulic power to the thrust reversers allowed the unlocked thrust reversers to be pulled open by aerodynamic forces. The amber "T/R UNLOCK CAS" message illuminated and the thrust reverser emergency stow switches began to flash. The pilot advanced the throttles to maximum takeoff power 0.7 second later in an attempt to go around; however, the thrust reversers reached full deployment 0.4 second after that. The airplane's full authority digital engine controls (FADEC), by design, prevented an increase in engine power while the thrust reversers were deployed. The red "T/R DEPLOY CAS" message was displayed in the cockpit, indicating that the thrust reversers were deployed, and the thrust reverser emergency stow switches continued to flash.

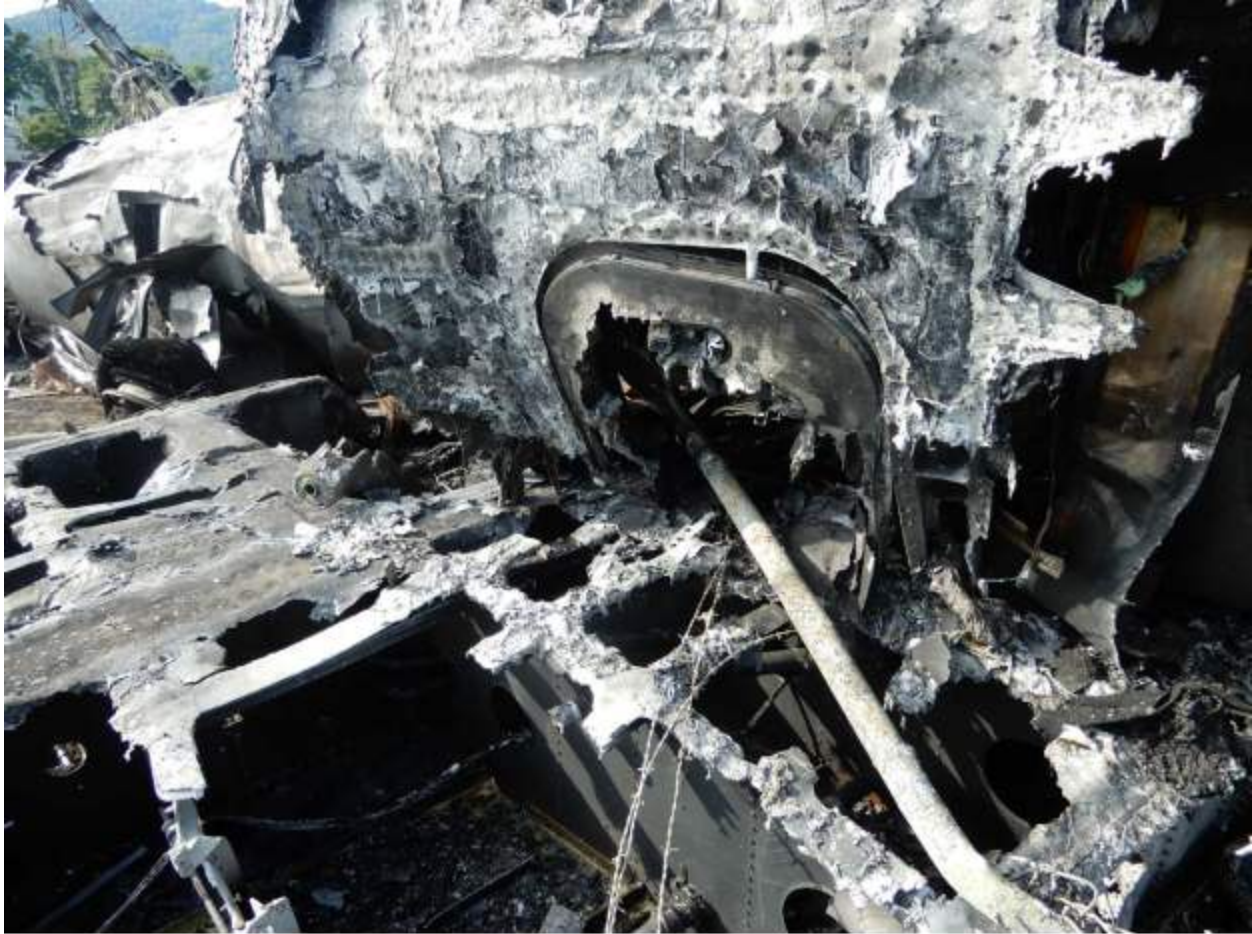
The pilots and passenger continued to struggle with the emergency escape hatch and observed heavy smoke coming from the lavatory, followed by flames. The copilot attempted to open the cabin entry door a second time, and he was able to push the door partially open with enough clearance to get all the occupants out. In a postaccident interview, the copilot reported that the exterior handle was likely pushing against the ground at the time, preventing it from opening fully.

Figure 3: Emergency escape hatch impaled by a metal fence post.
